LOCARCH SHELTER

Jean R. Saulnier, et al

Air Force Civil Engineering Center
Tyndall Air Force Base, Florida

May 1975

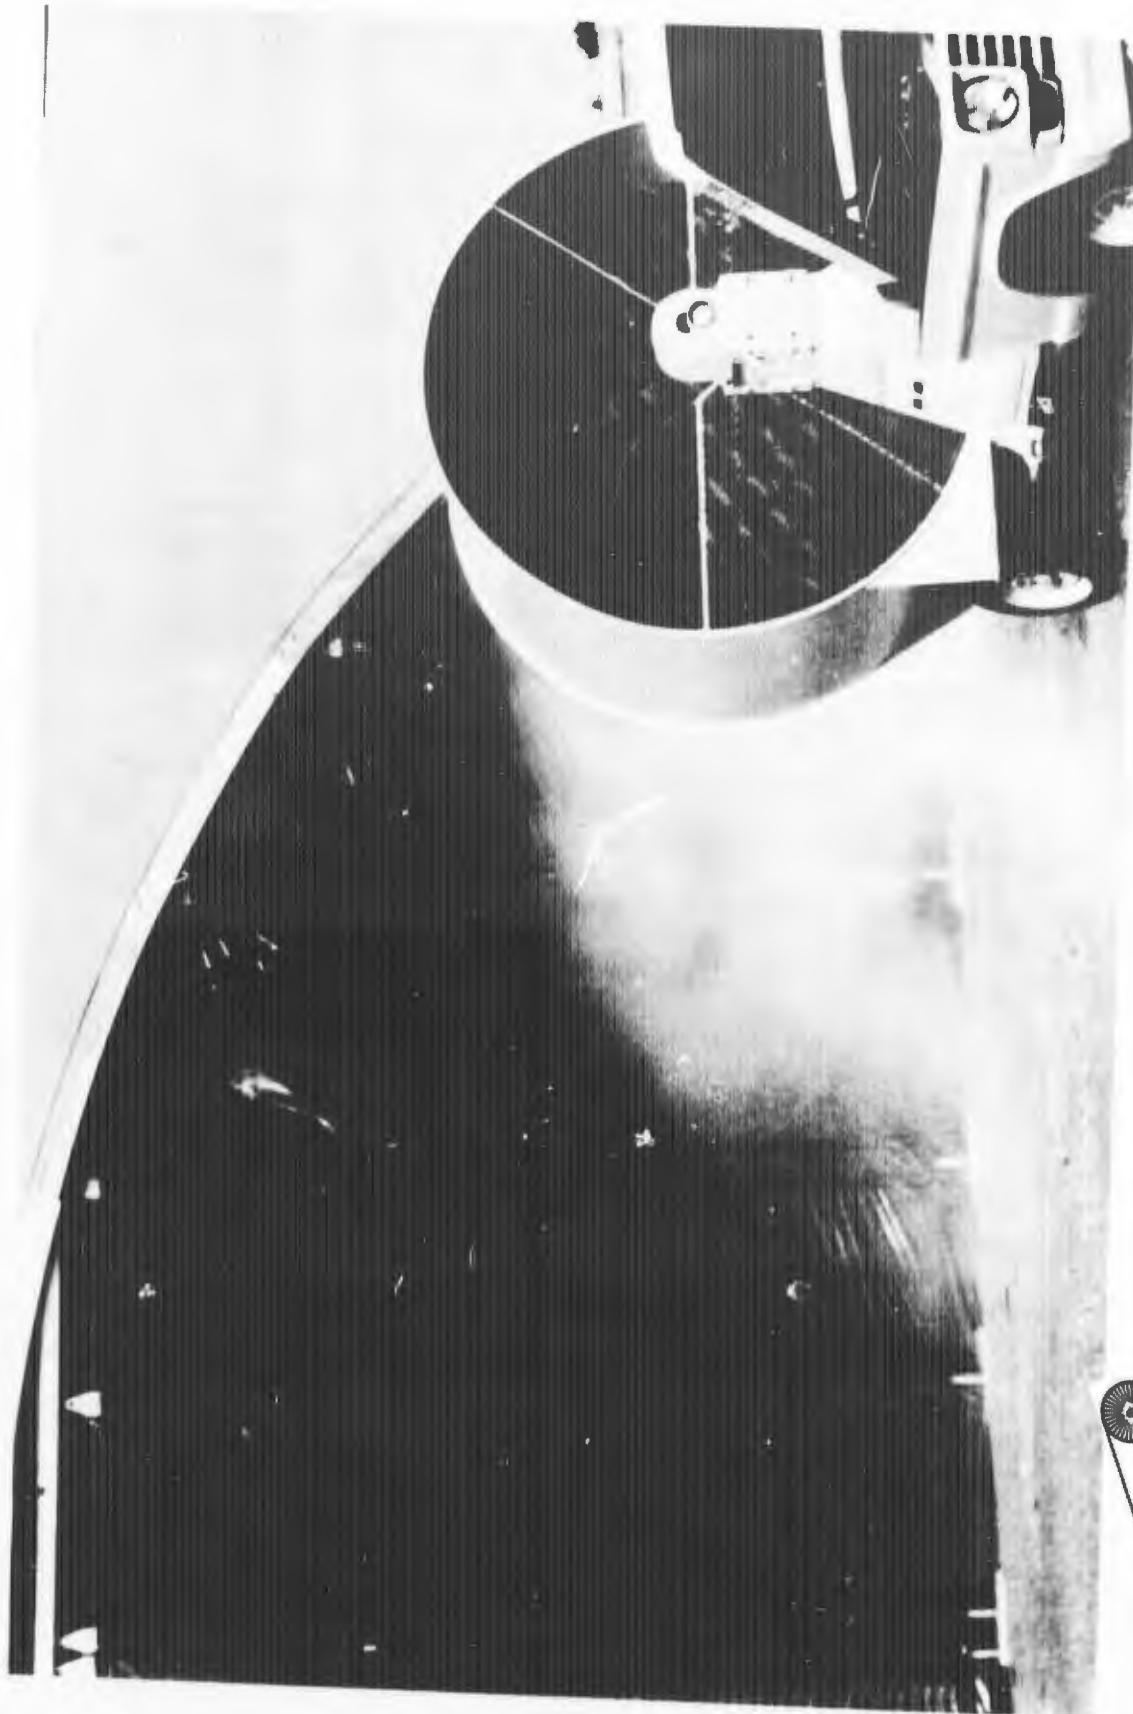
Figure 88 shows the wind machine test on the right side of the fabric door. The machine was positioned approximately 30 ft from the door when the photograph was taken. Most of the force was directed against the lower portion of the door at this point, so the wind machine was pulled another 25 ft away from the shelter in an attempt to provide coverage for half of the door. During this test phase the ground skirt was configured in two ways; first as in Figure 88, with the ground skirt pulled inside the building and sandbagged; and second with the ground skirt pulled outside the building and sandbagged. No water leakage was observed through the fabric or around any of the connection points except at the base of the door. The force of the wind and the volume of water immediately adjacent to the vertical posts where they were anchored in the ground, caused the ground skirt to be blown back somewhat and water entered freely. This was a direct horizontal exposure which would not normally be experienced. Figure 89 is a photograph from the inside of the shelter in the area where the sandbags were on the outside of the shelter to hold down the ground skirt. Water is seen to be pooling at the base of the door but the ground skirt sandbagged on the outside kept water from blowing directly into the shelter.

Figure 88 Wind and Rain Test on the Fabric Door

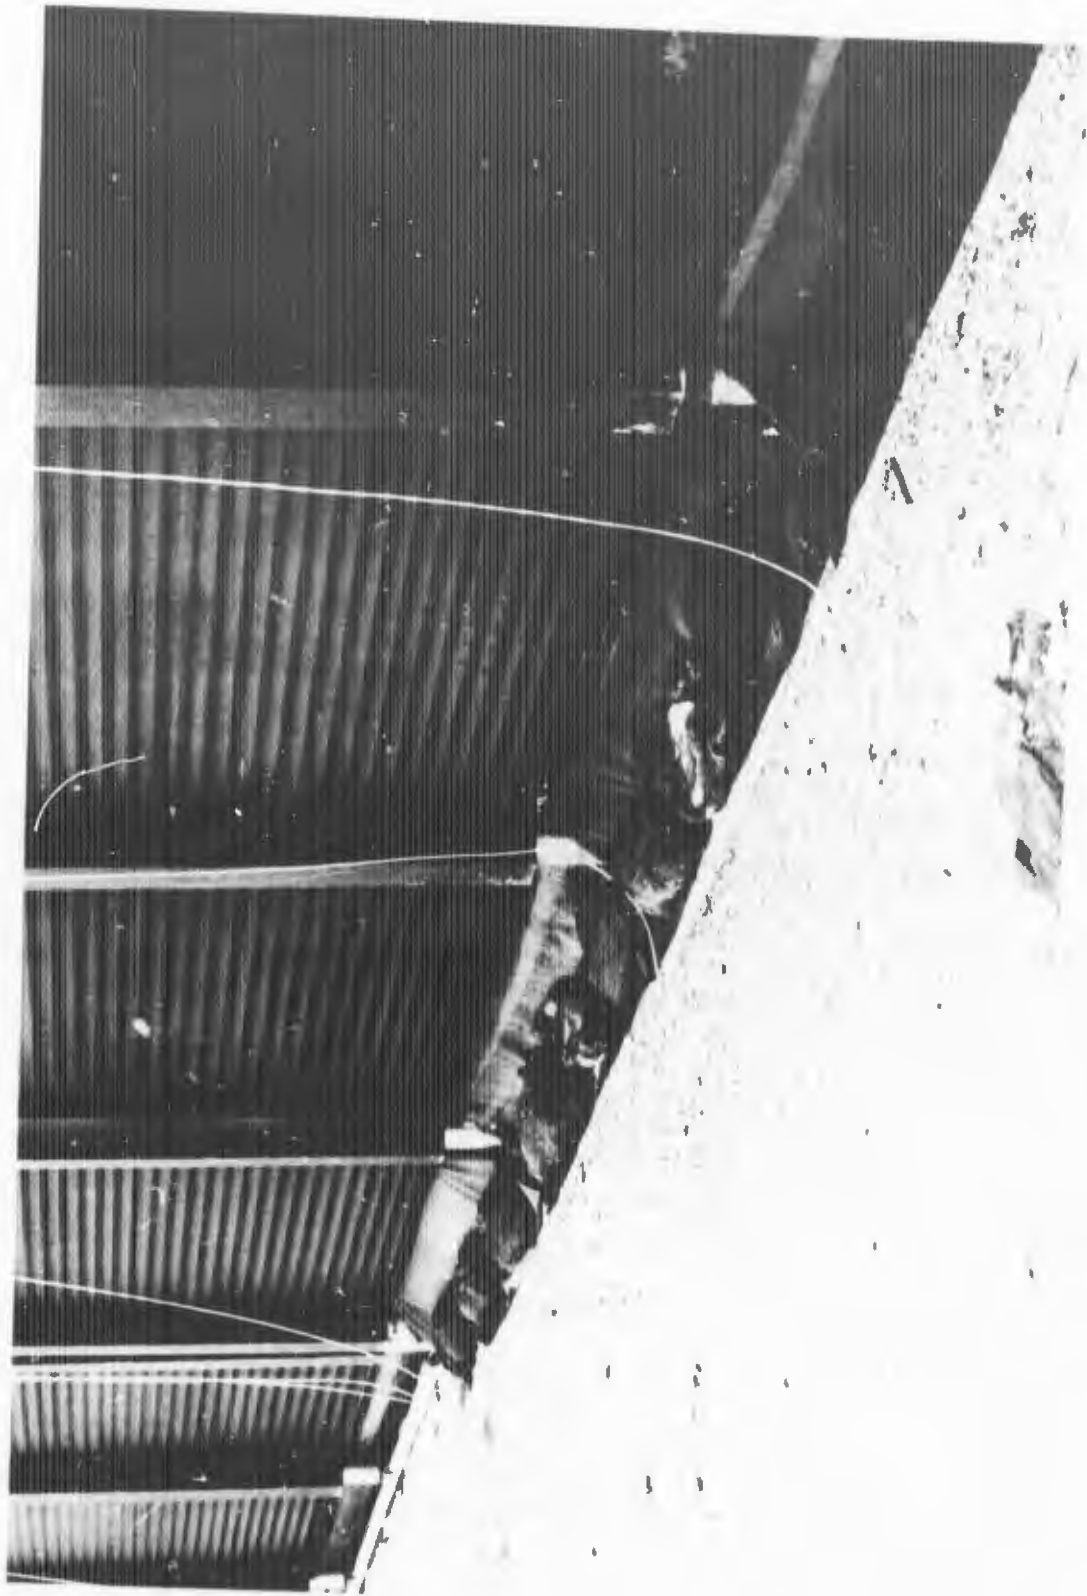
The last component of the building to be subjected to the rain test was the metal end wall. Figure 93 shows the sandbag arrangement for both sides of the door. The area immediately around the vertical posts where they anchor to the ground have openings which would allow the passage of water. On the left hand door with the sandbags inside the shelter the configuration appeared better. The areas at the vertical posts could be sandbagged from the inside. Figure 94 shows the wind machine in operation against the metal end wall. The ropes being blown around are the ropes used for opening and closing the door. In an actual situation they would be secured but during the test they were left to blow freely to see the effect on the door. The area that had the sandbags placed on the inside of the shelter was subject to most of the leakage. When the wind caught the ground skirt, it blew the sandbags

Figure 93 Metal Doors with Sandbags on Groud Skirt Prior to Wind/Water Test
